Laboratory Evaluation of Nitrile Fuel Tank Materials (Phase II)

ARL-TR-6627

September 2013

Army Research Laboratory

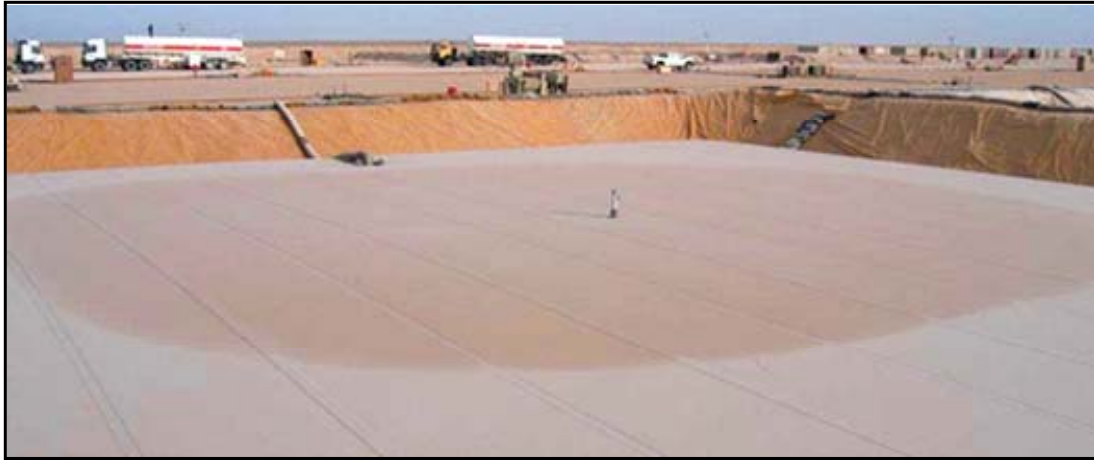
Figure 1. Typical coated fabric fuel/storage tank, showing wet spot on top panel surrounding the pressure release valve.

The U.S. Army currently has a large number of fabric reinforced elastomer tanks ranging in size from 100 to 210,000 gal used for the storage of fuels and water in the field. Examples of 50,000 gal fuel tanks are shown in figure 1. Collapsible fuel tanks, fabricated from urethane-coated nylon fabric, were first introduced by the military during the Vietnam conflict. Their performance, particularly in humid tropic environments, has been less than satisfactory. Unless formulated and produced according to stringent limitations, urethane-based fabric coatings were extremely susceptible to ultraviolet and hydrolytic degradation. At that time, tanks had to hold high aromatic gasoline, as well as diesel and jet propellant (JP) fuels. The only urethane that could handle the high aromatic gasoline fuels was the polyester urethane resins, which was more vulnerable to hydrolysis than the polyether urethane. Advancements were made in better understanding the mechanism of the degradation process in the 1980s. Suppliers then added hydrolytic stabilizers to the polyester urethanes to prolong their service life. The problem continued to linger, resulting in the deterioration and ultimate failure of external tank surfaces and seams, even when protective agents had been incorporated into the tank coatings (*2–4*).

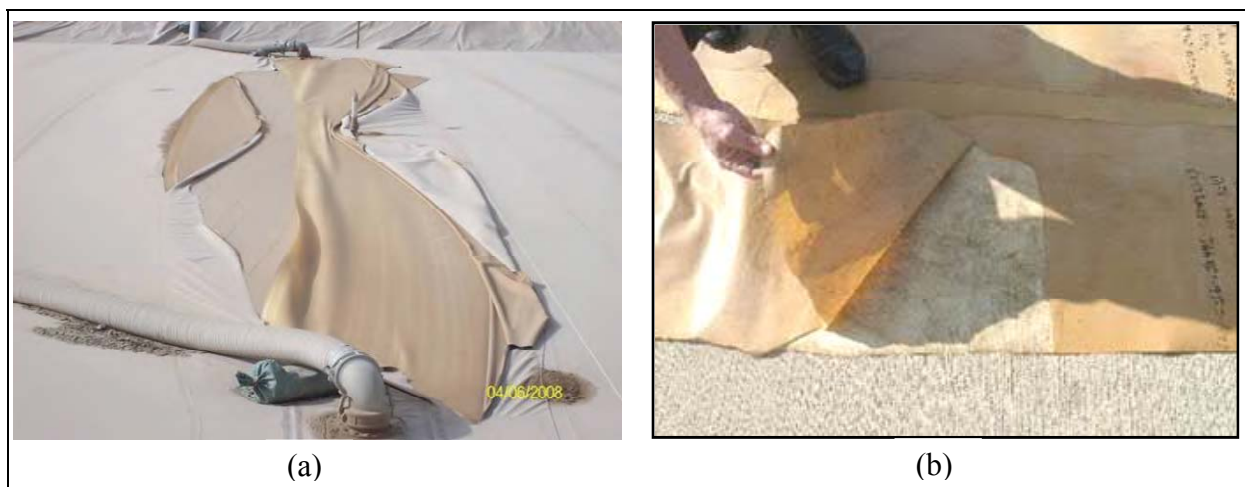
Figure 2. (a) Fabric delaminations of inservice fuel storage tanks and (b) large coating to fabric bonding failure due to surface fuel pooling and leaching.

In 1990, the U.S. Army issued a directive that these tanks would no longer be used by the Army for long-term storage of gasoline fuels. This change in policy allowed a shift in emphasis from high aromatic (gasoline) fuel-resistant coatings to more hydrolytically stable materials; thus, polyether urethanes could now be given more consideration as candidate fabric coatings. Concurrently, the U.S. Army readdressed and focused on determining the causes of coating and seam failures (5–8). Those studies demonstrated unequivocally that those failures were attributable to the leaching out of protective stabilizers from tank materials by contact with fuel puddles on the outer tank surface. The leaching action occurs regardless of the fuel type, but it is particularly severe in the case of diesel fuel. Because of this fuel’s low volatility and slower evaporation rate, any puddles on the tank surface prolong the extraction process, resulting in more extensive damage. Examples of fuel storage tank fabrics that have exhibited leaking of fuel to form puddles are shown in figure 2.

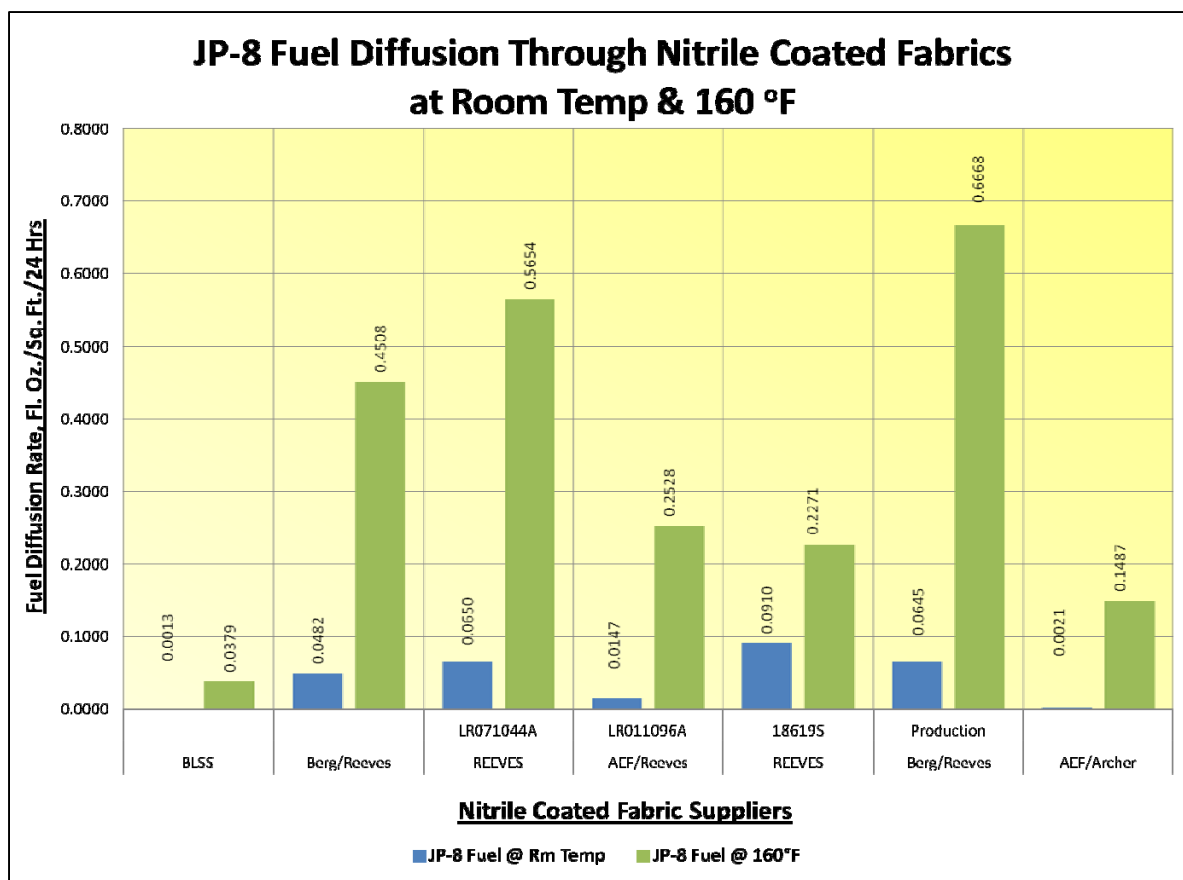
Figure 4. Effect of temperature on the permeation properties of nitrile-coated fabrics.

Figure 4 compares the diffusion rates of JP-8 at ambient temperature and at 160 °F. When fuel tanks are deployed in desert environments, it is not unusual for skin temperatures to exceed 140 F. It becomes important and relevant to evaluate diffusion and strength properties at elevated temperatures to predict in-field performance. Not surprisingly, when the test temperature was elevated to 160 °F, the diffusion rate increased significantly. All three of the Berg/Reeves materials exhibited an order of magnitude increase in diffusion rate at 160 °F. The BLSS nitrile showed an order of magnitude increase but the resulting diffusion rate at 160 °F of 0.038 was unexpectedly low. The AEF/Archer nitrile diffusion rate of 0.149 was also considered very low and acceptable.
